## How Long do Fiberglass Boats Last?

But just what can we say is the expected lifespan of a fiberglass boat hull? The answer varies with type of construction, choice of materials, and overall workmanship. However, since we are reaching the 50-year milestone for some venerable classes of boats that are actively being used, we can step back in time with some of these boats that have either been maintained over the years or recently restored to get a feel for how long these structures hold up in a marine environment.

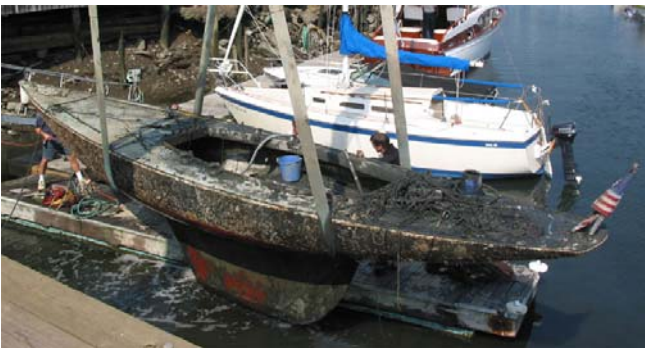
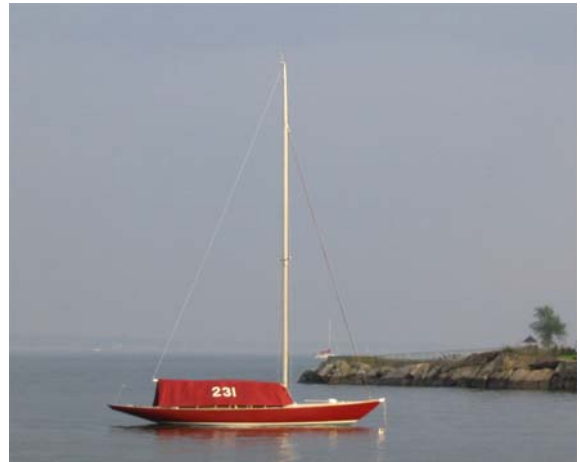
We know that wood eventually rots and steel corrodes at a set "allowance" per year. Maintenance is key to achieving even normal life expectancy with wood or metal boats. However, fiberglass hulls have been pulled from out of the weeds and up from the depths to be restored to original luster. A case in point is the salvage of Shields #231, which sank in 60 feet of water in 1999 when swamped by a Long Island Sound Easterly. She was floated again on October 2, 2002. Figure 1 shows the boat as it was hauled from the bottom and Figure 2 shows her restored with a new paint job. The boat went on to race competitively in her fleet.

**Figure 1 Pictures of Salvaged and Restored Shields Hull # 231**

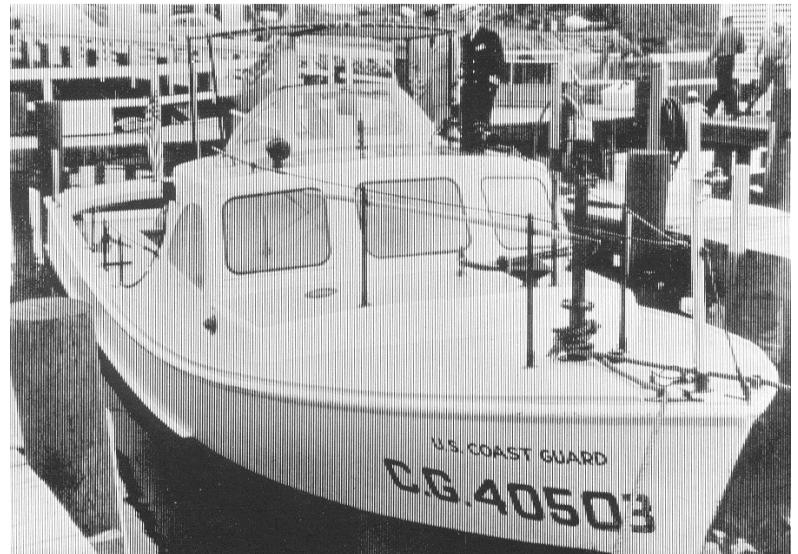
**Figure 3. USCG Hull 40503 [Owens-Corning Fiberglass, Fiber Glass Marine Laminates, 20 Years of Proven Durability]**

In 1962, Owens-Corning Fiberglass and the U.S. Coast Guard tested panels cut from three boats that had been in service 10 years. In 1972, more extensive tests were performed on a larger population of samples taken from CG Hull 40503, shown in Figure 3, which was being retired after 20 years in service. It should be noted that service included duty in an extremely polluted ship channel where contact with sulfuric acid was constant and exposure to extreme temperatures occurred during one fire fighting episode. Total operating hours for the vessel was 11,654. Visual examination of sliced specimens indicated that water or other chemical reactants had not entered the laminate. The comparative physical test data is presented in Table 1.

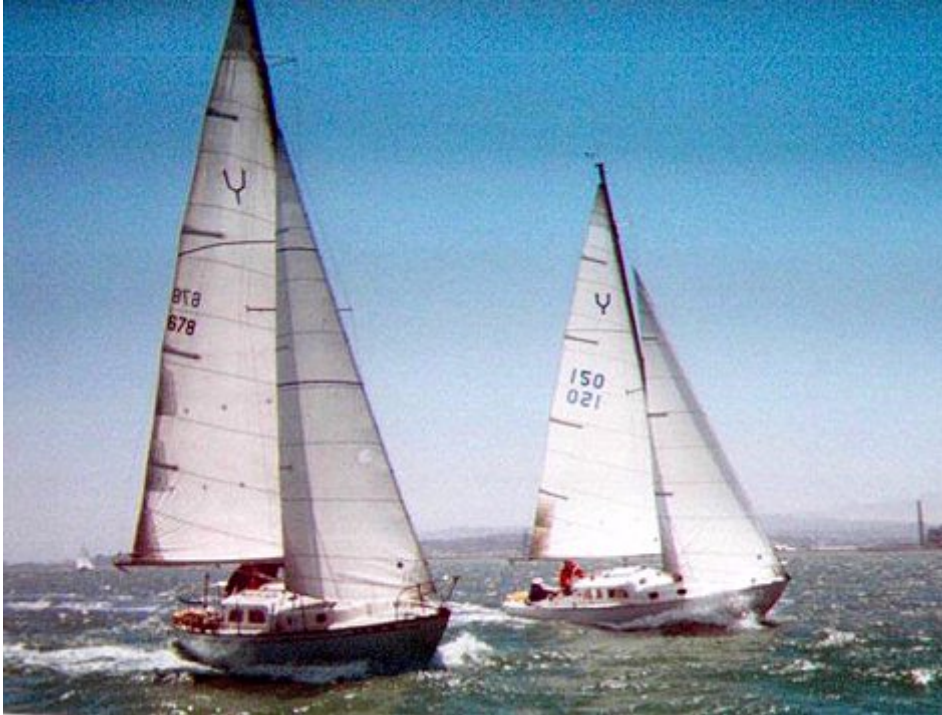
A Northrop and Johnson ad in the Aug '60 "Yachting" cites the Triton sailboat as being introduced in Jan 1959. Sales to June 1960 were listed at 173 at a production schedule of 3 boats per week. The listed price was \$9590 for the sloop. Everett Pearson developed the construction standards for fiberglass: "We designed the hull laminate from the waterline down so that the boat, laid over on its side with the entire weight of the boat resting on the keel and one square inch of the hull would yield not more than 1/2 inch and produce no structural damage to the boat." This is part of the reason so many of the early Tritons are still sailing today.

**Figure 4. Two Classic Triton Sloops**  
[<http://www.pearsontriton.com/history/billbell.shtml>]

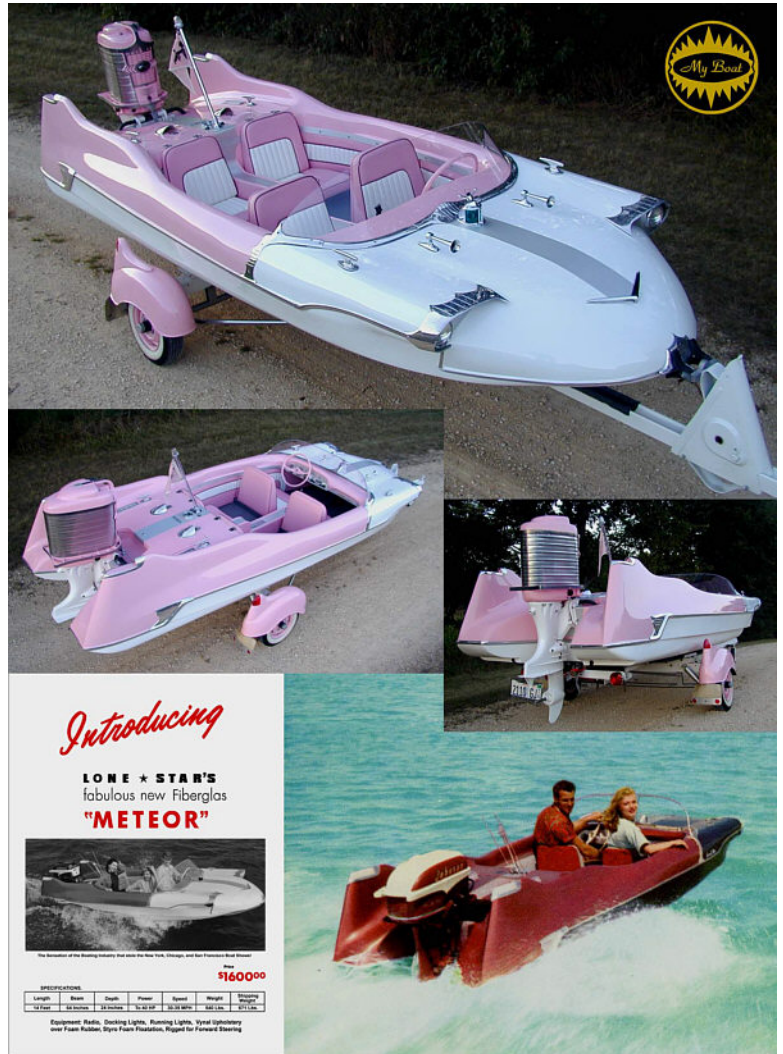
**Figure 6. Carp DeVille from page 4 of "Boats in the Belfry- the KevFin Collection"**  
[\[www.fiberglassclassics.com/galleries/bitb/default.htm\]](http://www.fiberglassclassics.com/galleries/bitb/default.htm)

Most gel coat on 50-year old fiberglass boats won't restore to showroom quality shown in Figure 6. Restored fiberglass boats of this era are now typically painted with polyester urethane topcoat, such as Awlgrip. However, we're still concerned about how long the mechanical properties of the pure laminate can last. Keep in mind that the part of the structure that will invariably fail first is not somewhere in the middle of a hull panel but at the edges where it is attached to hardware or bulkheads. Again, good selection of attachment methods and workmanship can drastically increase the life expectancy of an FRP structural detail.

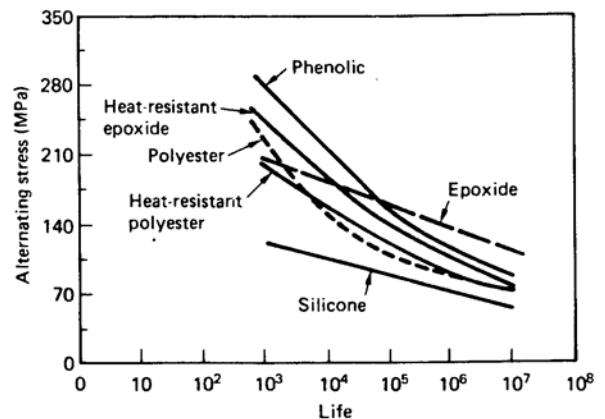
**Figure 7 S-N Curves for various Resin Systems [Konur & Matthews "Effect of the properties of the constituents on the fatigue performance of composites: a review," Composites, vol 20, no 4, July, 1989]**

The conclusion from the Halfbeak study is important because it stated that the long-term cyclic stress loads on the part were about 25% of the part strength. Indeed if a hull or propulsion related assembly experienced fatigue cycling on the order of 10<sup>5</sup> cycles, we'd expect to see a design safety factor of 4, in which case the cycling profile would determine the life of the structure. That is, we'd predict failure when the shaft turned say "one million times" instead of after 40 years of service. Figure 7 is a graph that shows how various resin systems respond to cyclic stress.

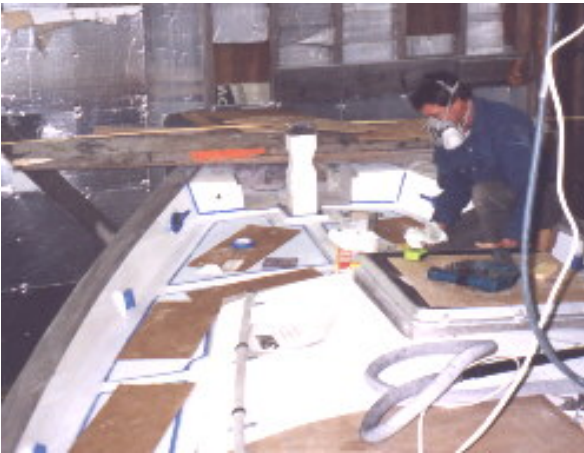
So what do all the tests and anecdotal evidence tell us about how long composites will last in a marine environment? Of course poor workmanship or improper use of materials can lead to premature structural failures, as observed by veteran repair shops such as Paul E. Luke. They find themselves working on aging fiberglass hulls that are often plagued with water impregnation of decks and bulkheads. They have extensive experience “re-coring” fiberglass decks and restoring the integrity of bulkheads with water damage, as shown in Figure 8.

**Figure 8. Deck “Re-coring” at Paul E. Luke, East Boothbay, Maine**  
[[http://www.peluke.com/Yacht\\_Repair/yacht\\_repair.html](http://www.peluke.com/Yacht_Repair/yacht_repair.html)]
